# Interstate 90 – Snoqualmie Pass East

## VISUAL IMPACT ASSESSMENT DISCIPLINE REPORT

January 2002

**Washington State  
Department of Transportation**

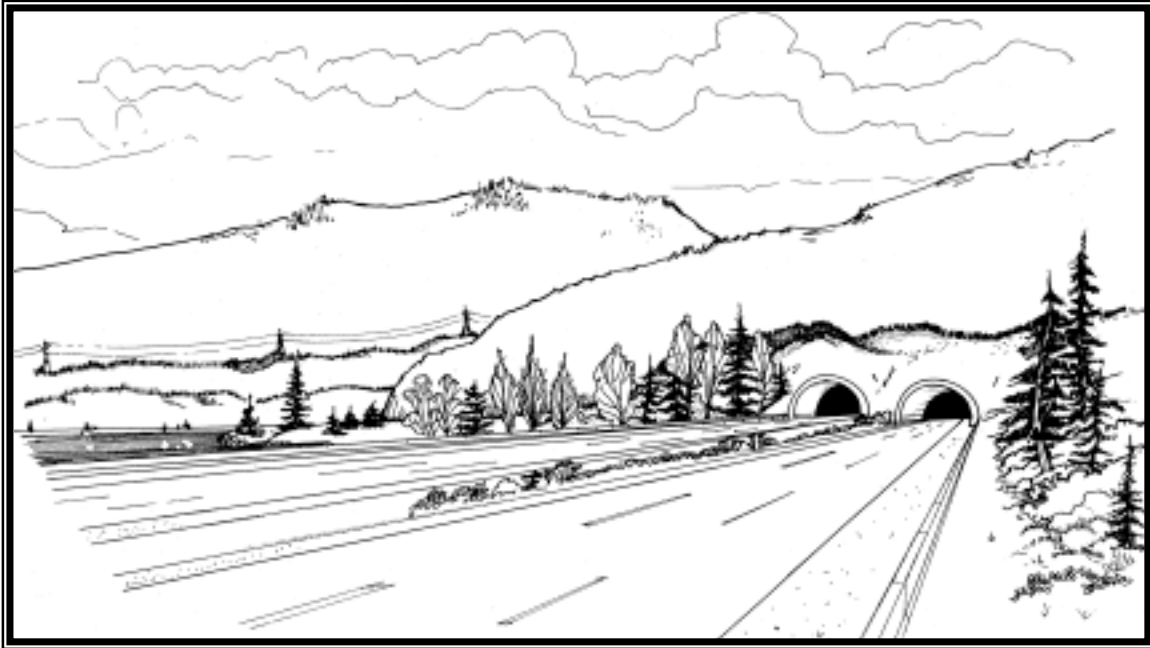
The design of traffic barriers will comply with the Architectural Design Standards and allow for lake views. Exposed rock faces should be treated with a weathering agent to blend the newly exposed areas with presently exposed rock faces. In addition, rock faces should be laid back at a 1.5 H: 1 V slope or stepped back to allow pockets of vegetation to grow. The existing roadbed, when removed, will be restored to a native Silver fir forest plant community. This will blend the road with the surrounding landscape. Figure 49 depicts the concept for Key View 6.

**Figure 49. Key View 6 - Tunnel Alternative**

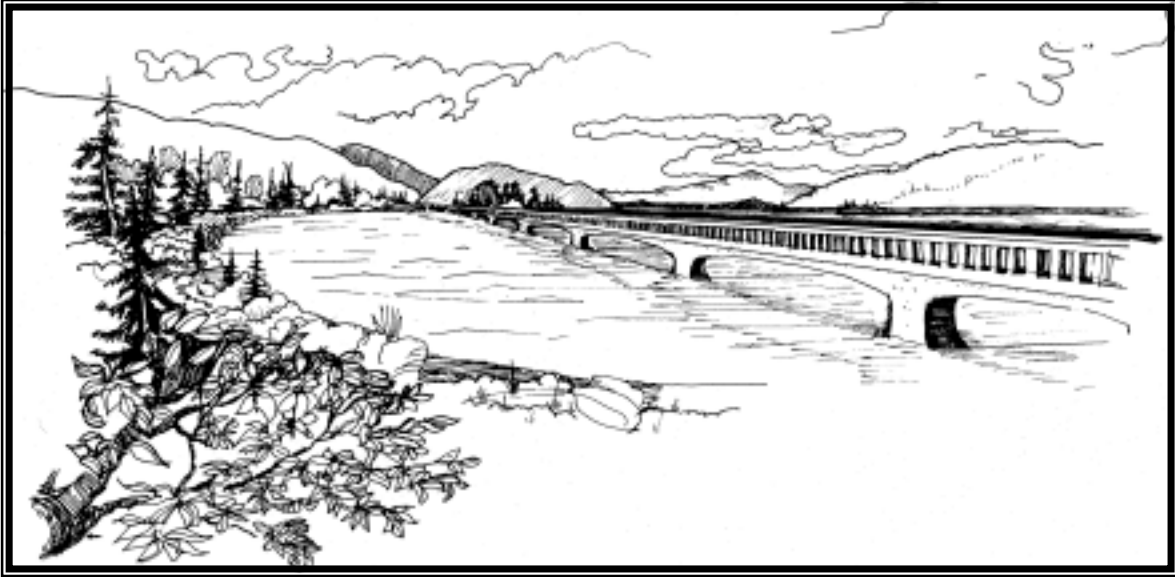
Mitigation for this part of the project should include restoring the former roadbed to a Silver fir forest plant community. This alternative would require disturbance of the vegetation when the road bends behind the hill. This would also entail large cut slopes. These cut slopes should be laid back at a slope flatter than or equal to 1.5H:1V so vegetation can be planted. Any exposed rock slopes should be treated with a weathering agent to blend the road into the exposed rock north or south of the road cut. Figure 50 shows the concept for Key View 5.

**Figure 50. Key View 5 - Bridge with shoreline restoration**

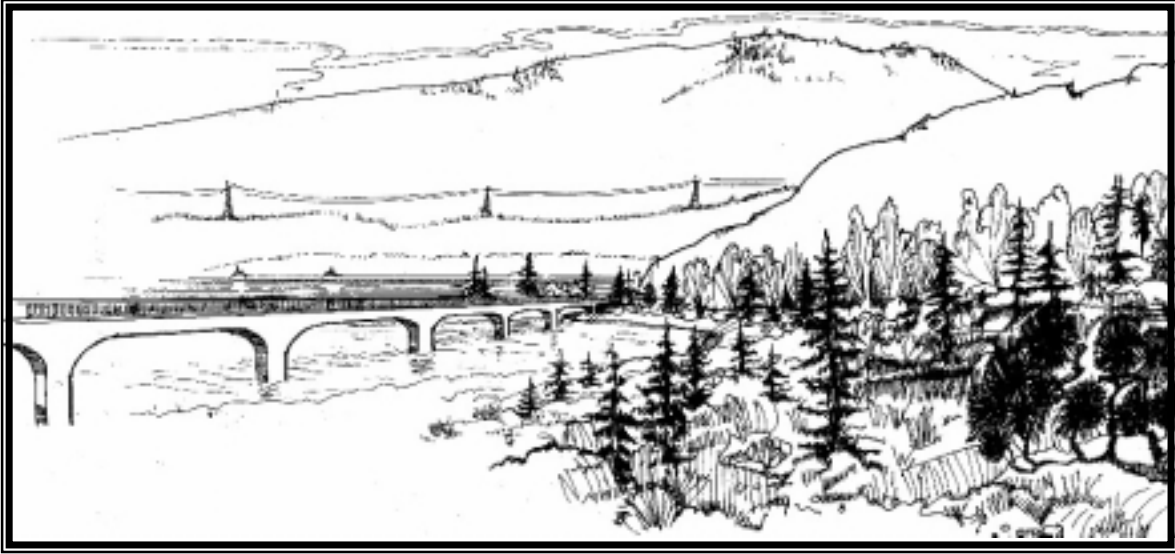
Mitigation measures for this alternative include the restoration of the existing roadbed to a native Silver fir forest community and the use of the Cascadian theme in bridge piers and railings. If this alternative were constructed, the view from this location would be of a forest in the foreground, the bridge over the lake in the middleground, and the hills in the background, as seen in Figure 51.

**Figure 51. Key View 6 - Bridge Alternative with restored roadbed**

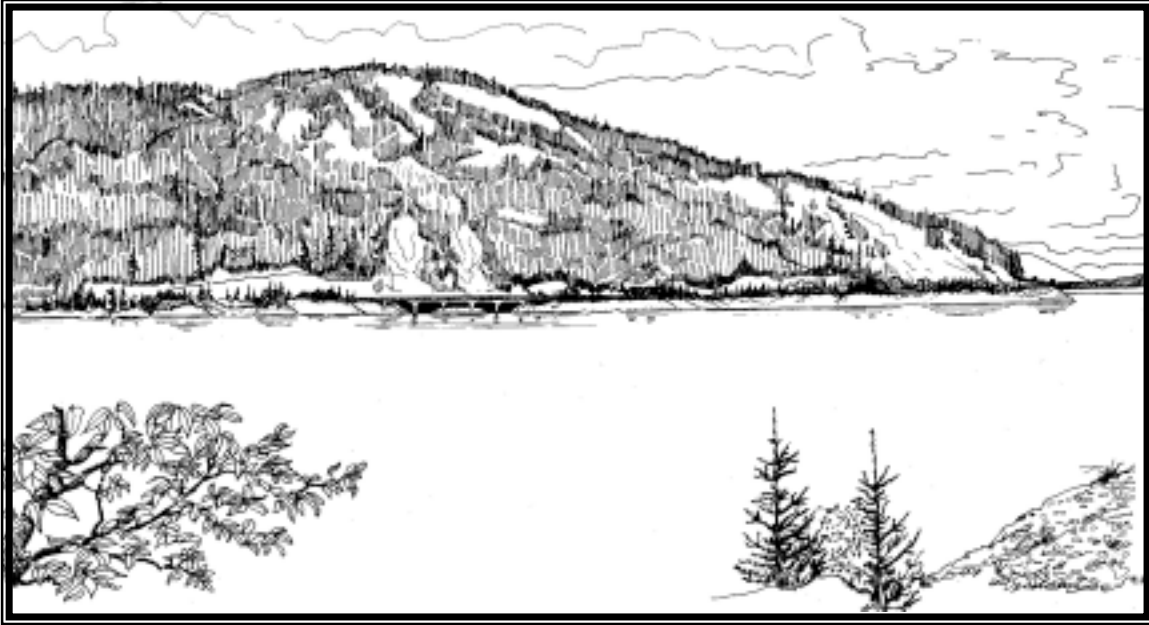
With the restoration of the native forest community this alternative will be blended into the existing forest. The tunnel portals can be blended into surrounding rock using colored concrete or stains. Bridges built over the rock chutes will have the arched Cascadian design theme to carry a common rhythm throughout the corridor. The concept for this alternative is seen in Figure 52.

**Figure 52. Key View E after mitigation**

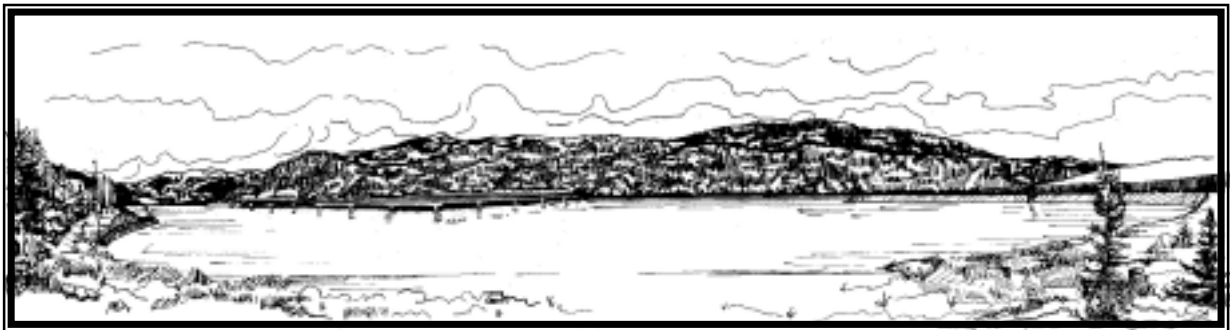
**Figure 53. Key View G - Bridge Alternative**

The bridge piers in this alternative should be designed using the Cascadian arch and other elements to comply with the Architectural Design Standards for this project. Figure 53 shows the view of the bridge over the lake from this perspective.

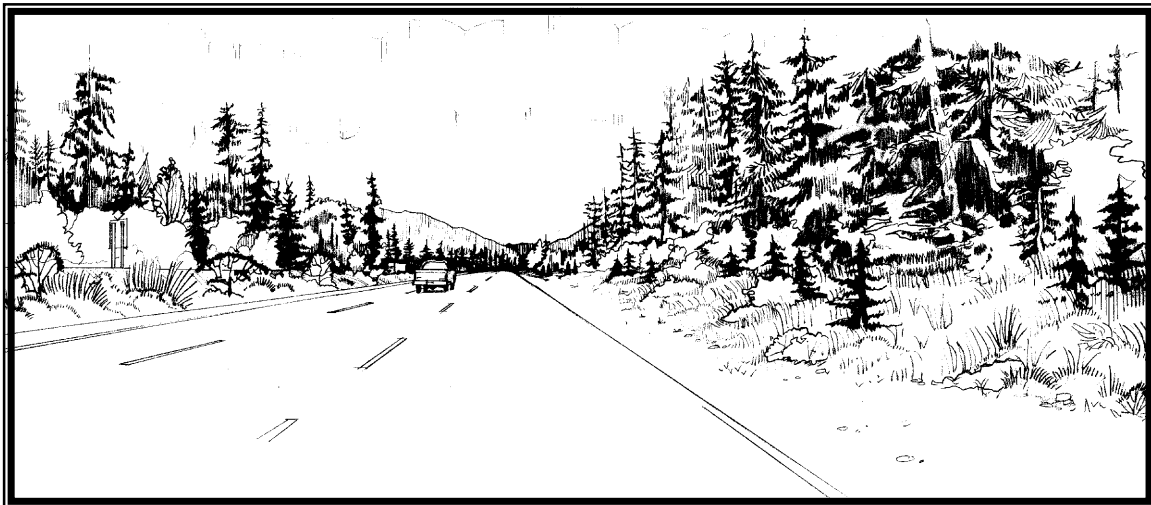
Mitigation at this Key View location could include installing guardrail to allow for the retention of large trees in the right of way. The removal of the on and off ramps for the Price Creek snow park will allow for visual continuity. The concept for this Key View is seen in Figure 54.

**Figure 54. Concept for Key View 8**

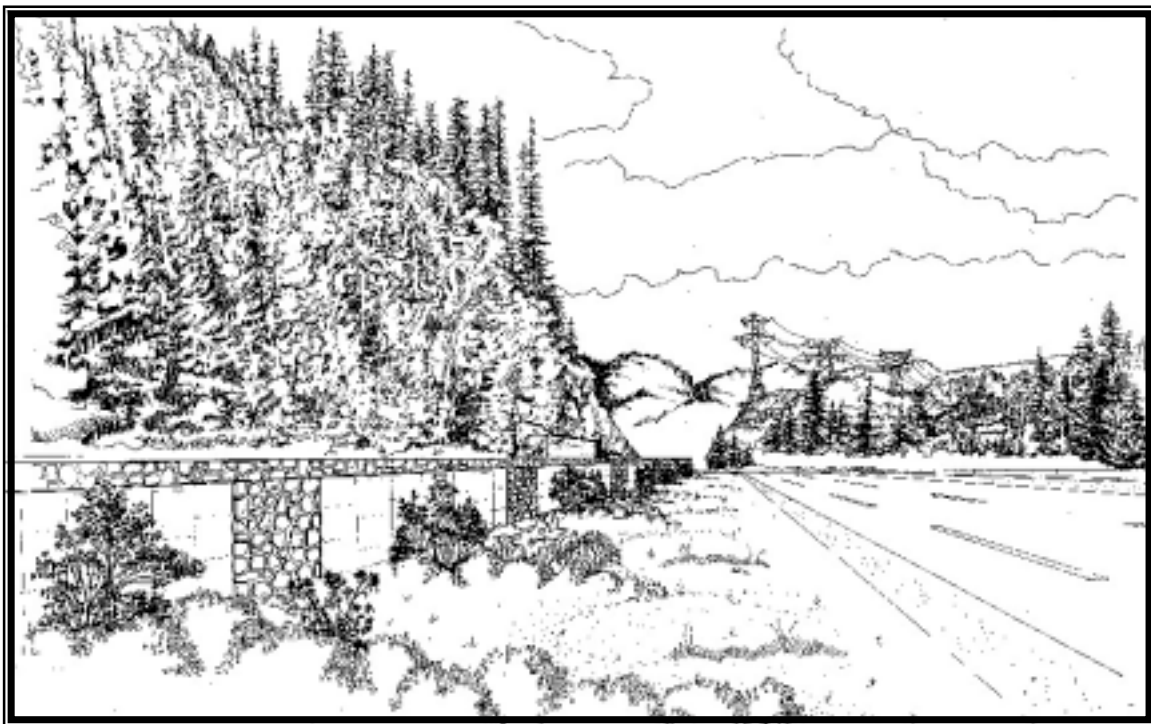
Retaining walls will be designed using the Architectural Design Standards for this project. The median will be planted with shrubs to soften the face of the wall and to provide visual interest and color. Traffic barriers should be high to block the view of transmission lines from people in cars to the greatest extent possible. These barriers will comply with the Architectural Design Standards. The concept for Key View 11 is seen in Figure 55.

**Figure 55. Key View 11 after mitigation**

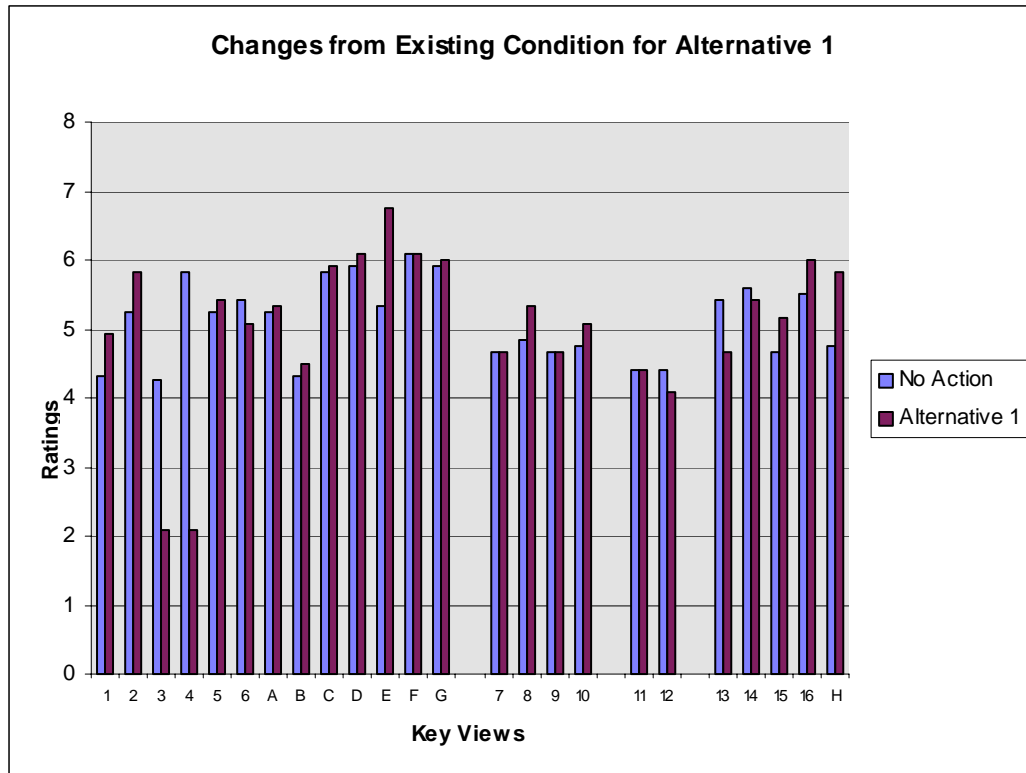
This is the “Long Tunnel” alternative combined with the narrow width median from MP 67 to MP 68. Median widths would increase for much of the project corridor but would narrow in Landscape Unit 4. The long tunnel lowers the visual quality rating, for views from the road, in Landscape Unit 1 to low. The view of the lake would be lost while in the tunnel. While ratings for the view from the road are lower, the view toward the road will have higher visual quality ratings than the existing condition because the footprint and profile of the road would be decreased. This can be seen in Figure 56.

**Figure 56. Changes in Visual Quality Ratings for Alternative 1 from the No Action Alternative**

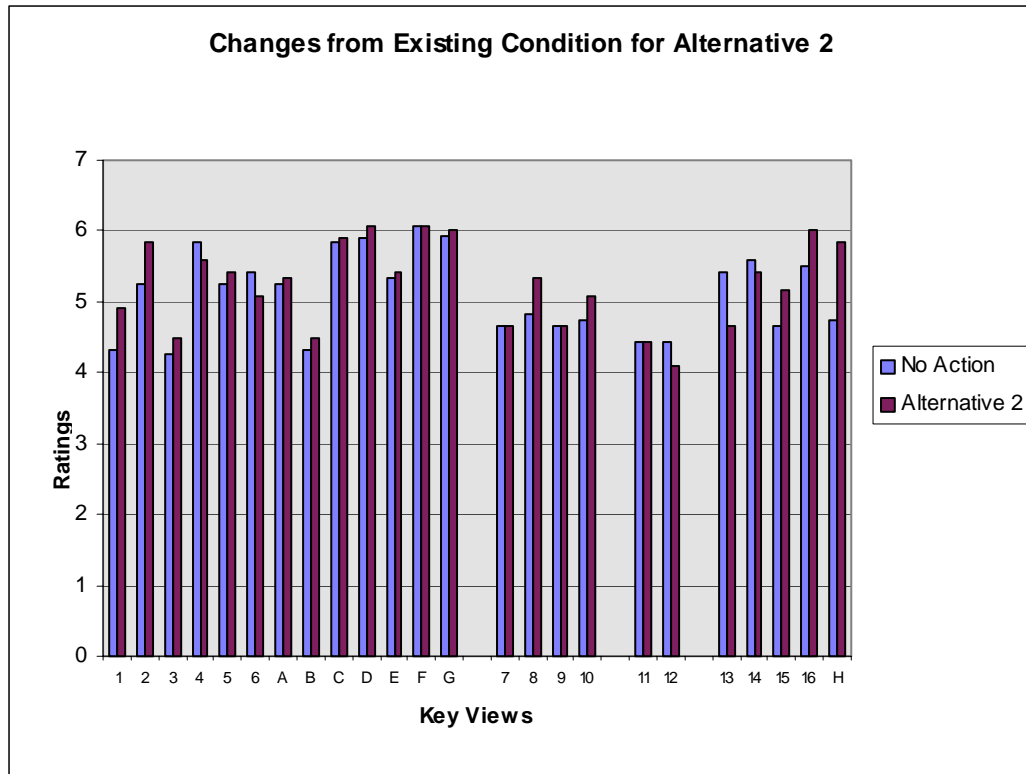
**Figure 57. Changes in Visual Quality Ratings for Alternative 2 from Existing Conditions**

Views *toward* the road are all equal or higher than existing conditions. Views *from* the road are lower at the entrances to the tunnels, at MP 66 where the transmission lines are expected to be more visible, and where the narrowed median may allow views of opposing directions of traffic. Table 2 shows the number of views and their direction of change for Alternative 2.

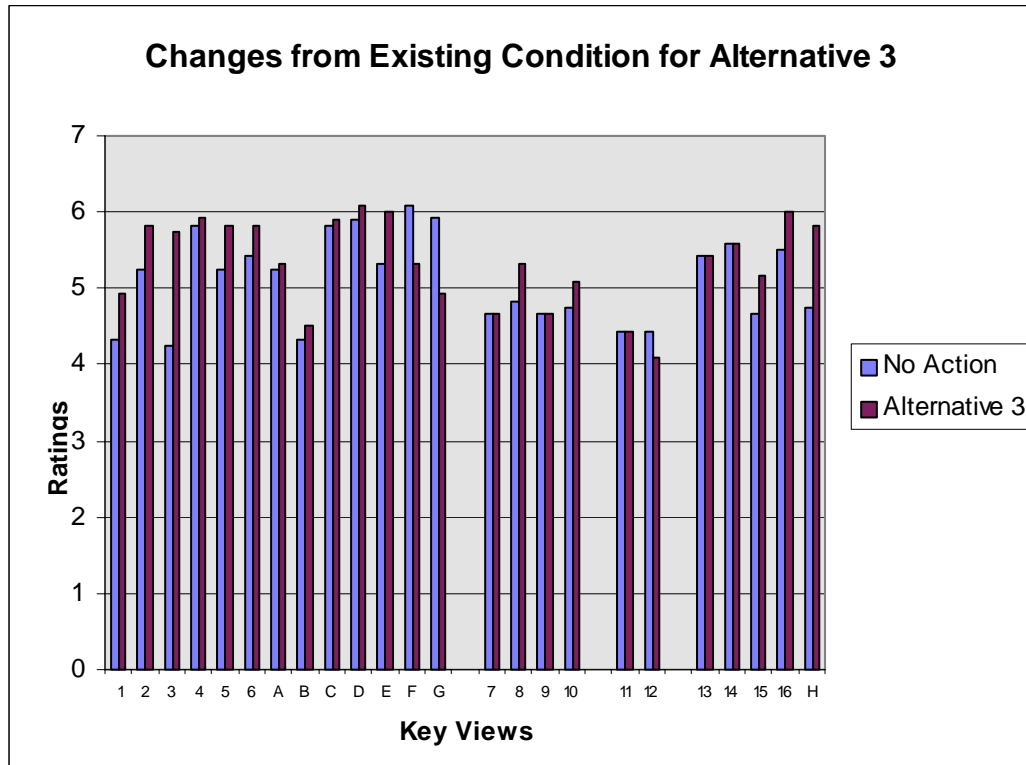
**Figure 58. Changes from the Existing Condition for Alternative 3**

Visual quality ratings *from* the road are higher for this alternative because the bridge brings the traveler closer to the water, especially on the eastbound lanes. As in the other alternatives, Key View 12 is lower than existing conditions because the necessity of removing vegetation increases the views of the transmission towers. Views toward the road, especially from the southern end of the John Wayne Trail at Lake Keechelus, are lower because of the construction of the bridge into the lakebed and the cuts into the hillside near MP 60.70. This study also assumed the design of the bridge structures would be visually pleasing, especially from viewpoints across the lake. Table 3 shows the number of views and their direction of change for Alternative 3.

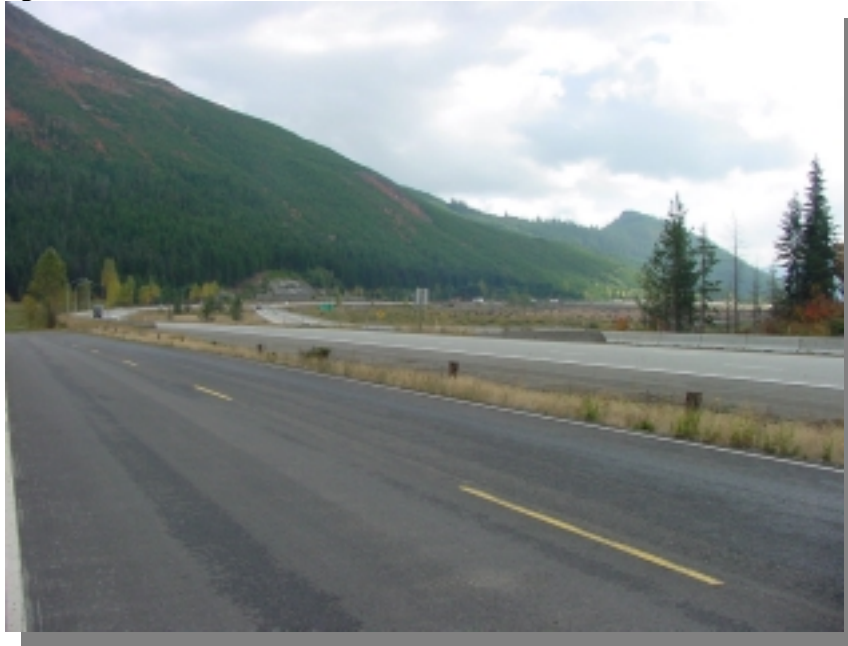
**Figure 60. View south from FS Rd 4832 at MP 55.10.**

Figure 60 shows the view from FS Rd 4832 at the beginning of the project. The view is south looking toward the lake. This road is traveled by people going to Gold Creek Pond, a popular stop for picnicking.

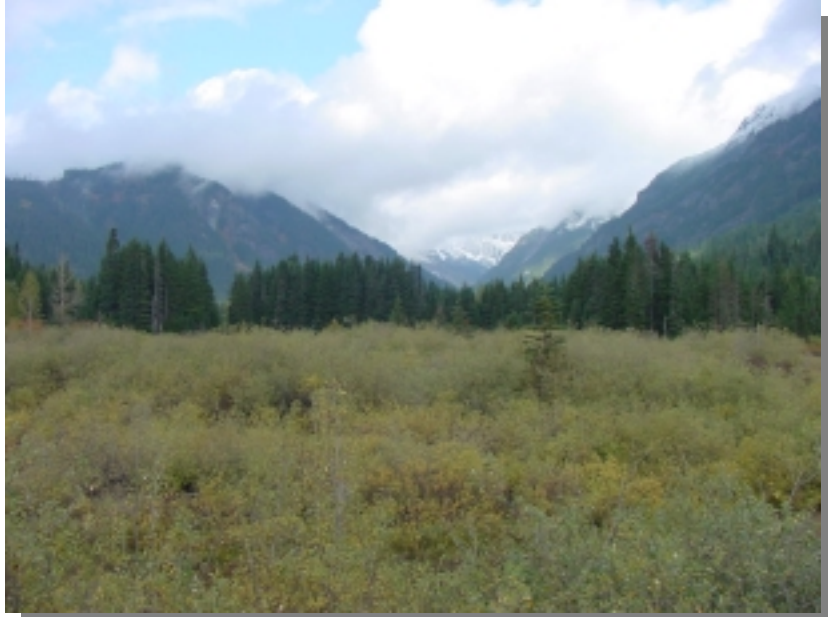
**Figure 62. View up Gold Creek Valley MP 55.5 vicinity**

Figure 61 shows the view from FS Rd 4832 up Gold Creek Valley. This view is one that can also be seen from I-90 where it passes over the Gold Creek Bridge.

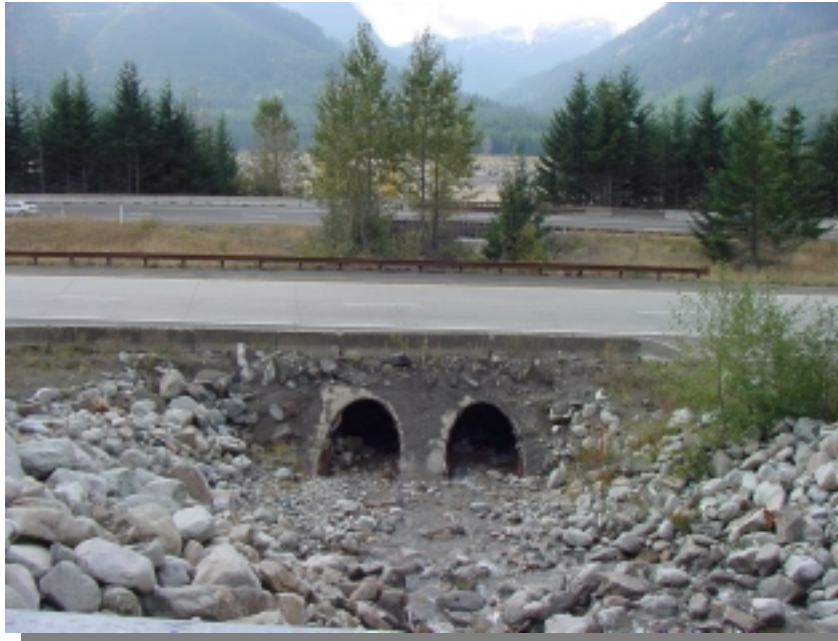
**Figure 63 View from FS Rd 4832 of Gold Creek culvert under Eastbound I-90**

Figure 63 was also taken from FS Rd 4832 looking toward I-90 and the two culverts through which Gold Creek flows. These culverts will be replaced by a bridge as a part of this project.

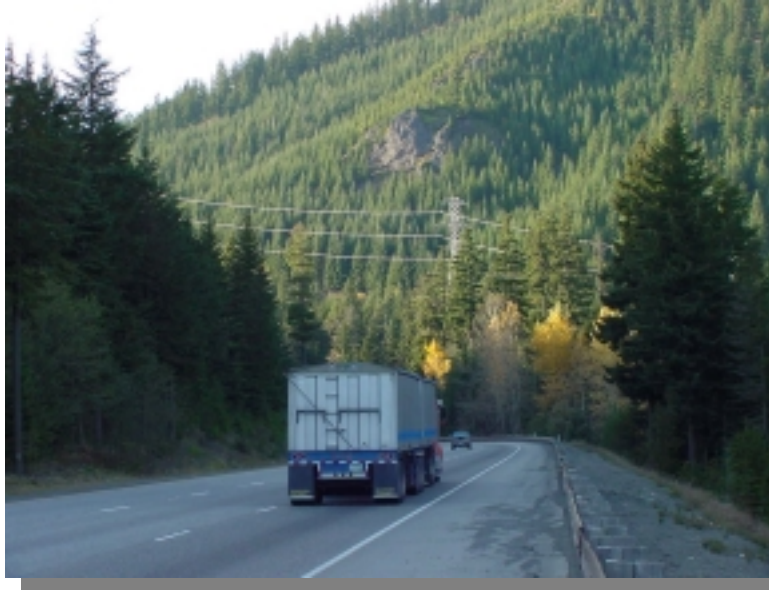
**Figure 688. Power lines at Westbound MP 67.5**

Figure 68 shows the transmission lines as they stand above the highway at westbound MP 67. 7. The lines parallel the highway to the north until they cross I-90 in the vicinity of MP 65.7. Because these lines are uphill from the highway, the traveler does not see them after the vehicle passes the tower in the center of the view. The project will not impact this part of the hillside.

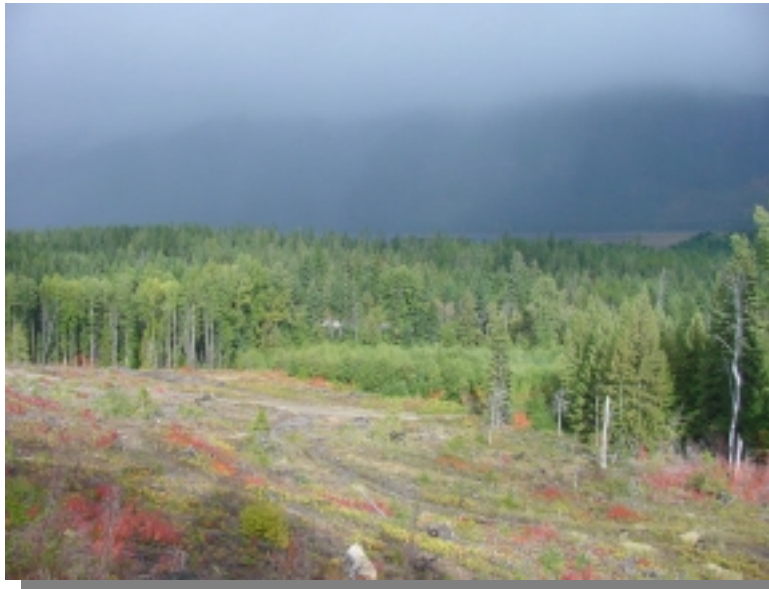
**Figure 699. Typical regrowth on logged slope in project viewshed**

Figure 69 shows the view toward I-90 from a clear-cut slope south west of I-90. This photo was taken from a little used Forest Service Road above the vicinity of MP 69. It shows the current condition of clearcut slopes that will more easily be seen from I-90 if trees are removed. I-90 can be seen as a small white spot in the center of the photo.

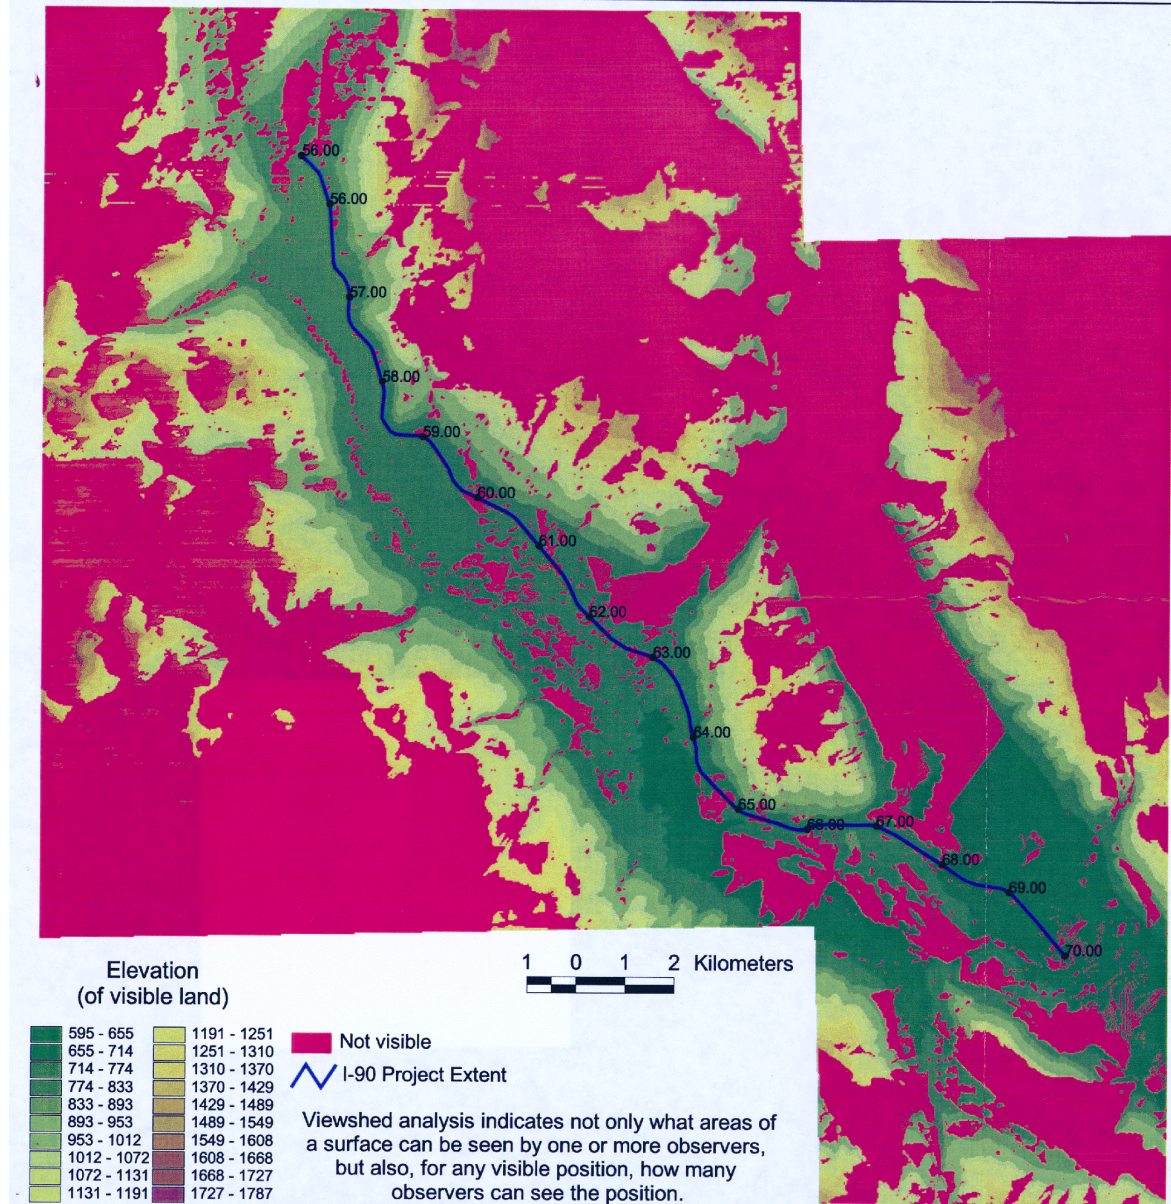
## 10.5. APPENDIX F – VIEWSHED ANALYSIS

This diagram is a geographic information system (ArcInfo) analysis of what is viewable from the road. All items in red are blocked from the view of the traveler on I-90.
